**Village of Washingtonville**

## **Water and Sewer Infrastructure Master Plan**

**March 2020**

Delaware Engineering, D.P.C.

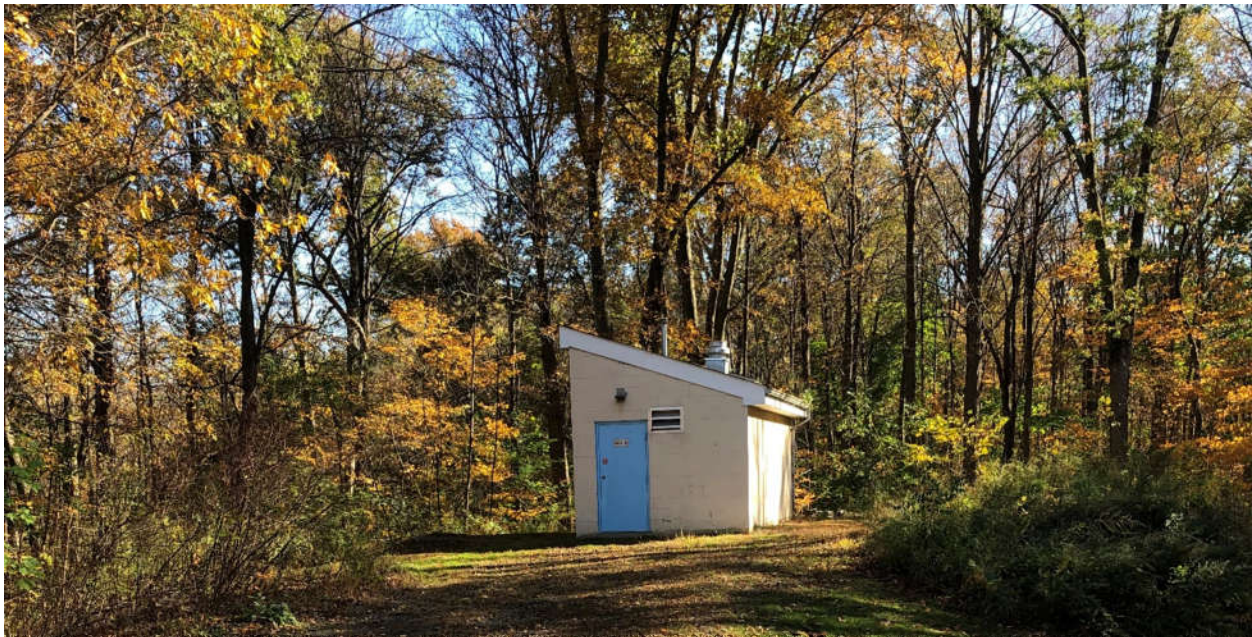
Well Field well

**Well #1A** – This is a primary Village source well that was drilled in September 1994 to replace Well #1. Its yield is 1,050 gpm at 29.5 feet pumping level, the pump intake is at 43 feet. Recommended safe yield of 750 gpm, stated in the withdrawal permit. It has a specific capacity of 143.69 gpm per foot of drawdown at 786 gpm. This well is typically pumped at 550-650 gpm. The well had a static level of 18 ft when drilled. The well screen was replaced in 2016. The static level has typically been between 18' and 20' in recent years.

Surrounding base flood elevation is 312 ft, while the finished floor elevation of well house is 317.4 ft and top of casing is 321.6 ft.

Details: This is a 44.7 ft deep gravel packed well; 38-1/2 feet of 30" casing inside 36" outer casing, #5 gravel pack between casings. A 6-foot length of 30" diameter stainless steel screen (150 slot), with grout seal around outer casing to 20 feet.

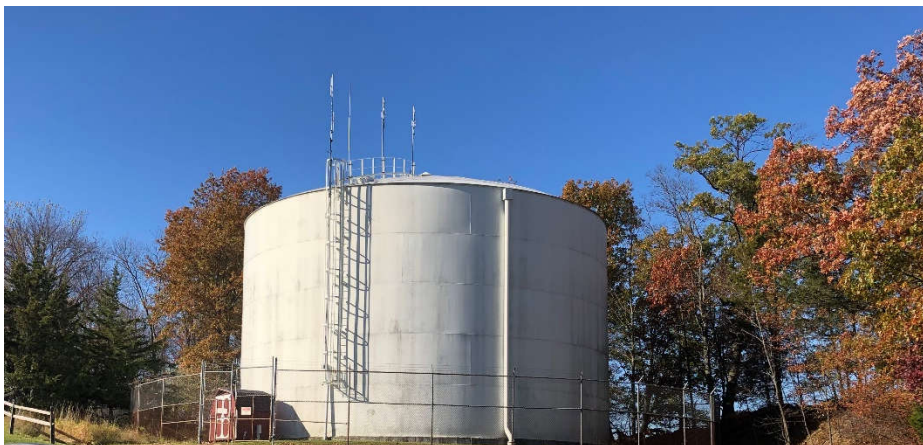
The system has two 800,000-gallon storage tanks (Prides Crossing and Clinton Street tanks) that are hydraulically interconnected. There is a hydro-pneumatic system across the street from the Clinton Street tank that boosts pressure to adjoining homes that are at higher elevations for which the Clinton Street tank cannot always provide minimum pressure. Both tanks were inspected in 2015, with next inspection due 2020. The inspection reports are included at Appendix C.

Water storage tank

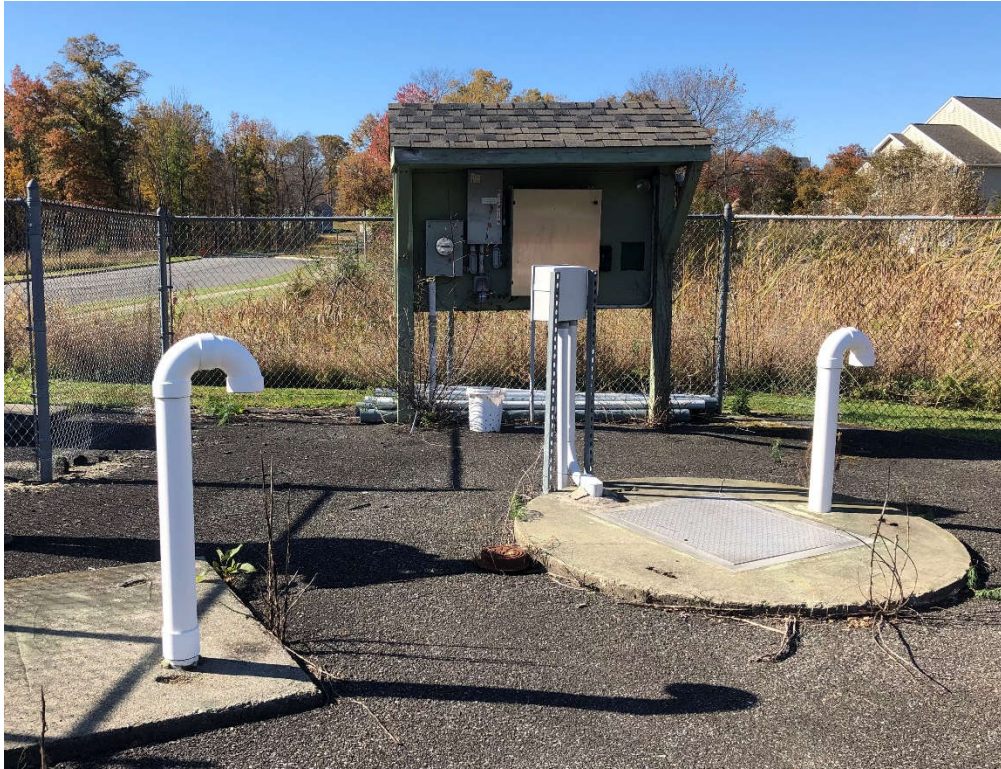
Pump Station

### **Woodfield Pump Station**

The contributing collection system has manholes within the adjacent wetland that contribute to inflow/infiltration (I/I), but have not yet been found. Heavy grease is an issue at this site. The slide rail system needs replacement as corrosion is causing separation at wall supports.
